BRADFORD CITY No. 3 DAM

NDI No. PA 00025
PennDER No. 42-10

PHASE I INSPECTION REPORT
NATIONAL DAM INSPECTION PROGRAM

Bradford City No. 3 Dam, McKean County, Pennsylvania
NDI No. PA 00025, PennDER No. 42-10
Marilla Brook
Inspected 8 and 9 November 1978

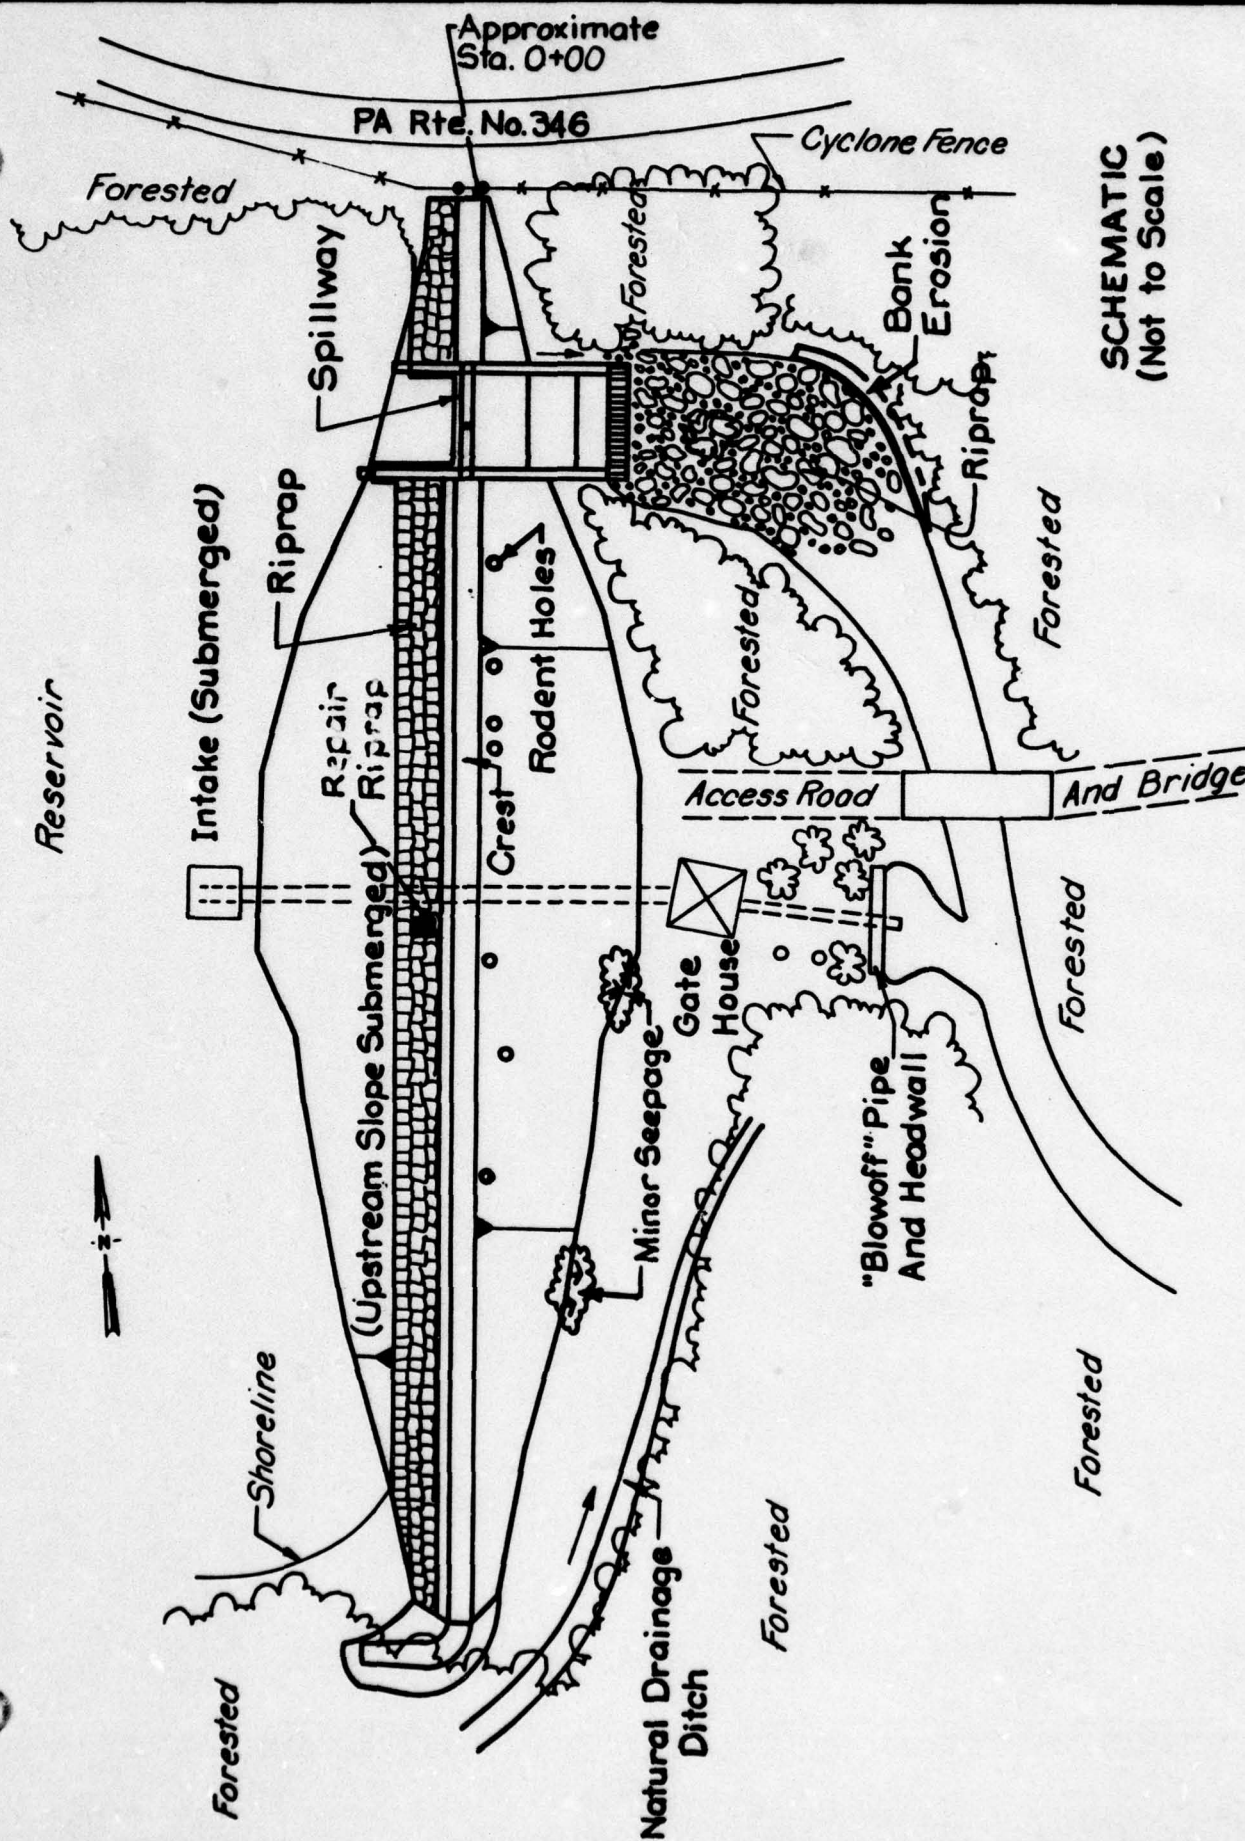
FIELD SKETCH

Several rodent/groundhog/animal burrows were observed in the downstream slope of the embankment. The locations of these holes are shown on the field sketch in Appendix A.

VISUAL EXAMINATION OF	OBSERVATIONS	REMARKS OR RECOMMENDATIONS
RODENT/ANIMAL BURROWS	Several rodent/animal burrows were observed. The approximate locations of these holes are shown on the field sketch.	These burrows should be repaired. A groundhog/rodent/animal control program should be implemented.

- 1) Repair of the animal burrows in the embankment and establishment of a rodent control program.
- 2) Repointing of the joints of the sandstone block spillway structure.
- 3) Repair of the riprap on the upstream face.
- 4) Placement of riprap protection along the left bank of the downstream channel where erosion is occurring.
- 5) The periodic inspection of the seepage areas to identify a change in quantity or the exiting of muddy water from these areas and, if necessary, to assess the stability and piping potential of the dam in connection with the seepage conditions.

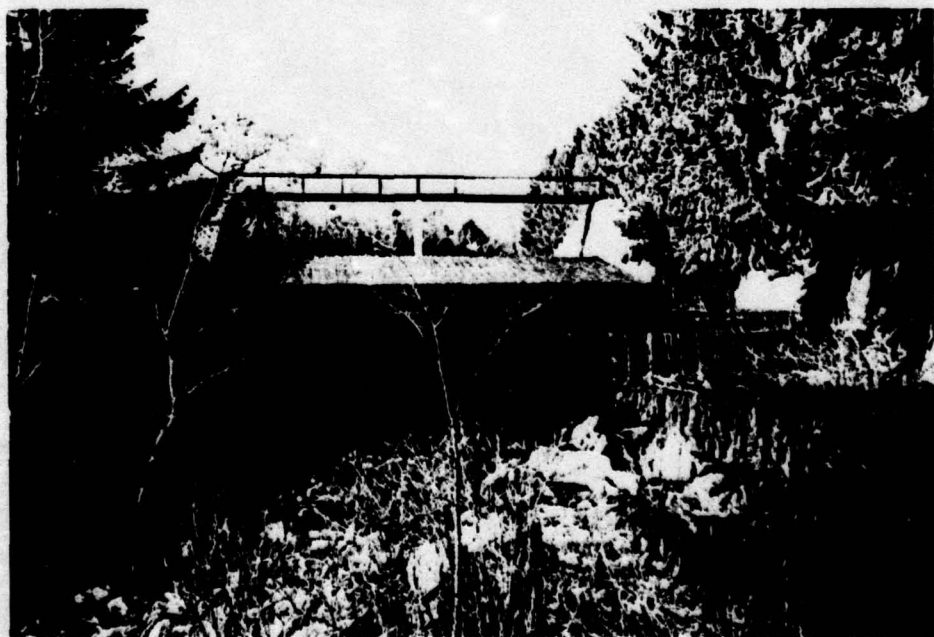
The spillway structure was found to be in good overall condition. Some minor debris and vegetation was observed in the discharge channel. Some of the joints in the masonry block training walls need repointing. The steel walkway and bridge pier over the spillway were in good condition.

- c. Visual Observations - Except for minor amounts of debris and vegetation in the downstream channel, no deficiencies were observed in the spillway or spillway channels. Frequent routine maintenance should remove debris from the spillway and spillway channels. The vegetation in the channel should be removed.

PHOTO 2. View of Downstream Portion of Spillway

- 1) The owner should initiate an engineering study to further evaluate the spillway capacity and develop recommendations for remedial action as necessary.
- 2) The removal of the vegetation and debris from the downstream channel.
